# THE CAUSES OF BOAT HULL BLISTERS

Thomas J. Rockett, Ph.D. Vincent Rose, Ph.D.

Department of Chemical Engineering
University of Rhode Island
Kingston, Rhode Island

This report is the product of work accomplished under U. S. Coast Guard Grant #1501.83

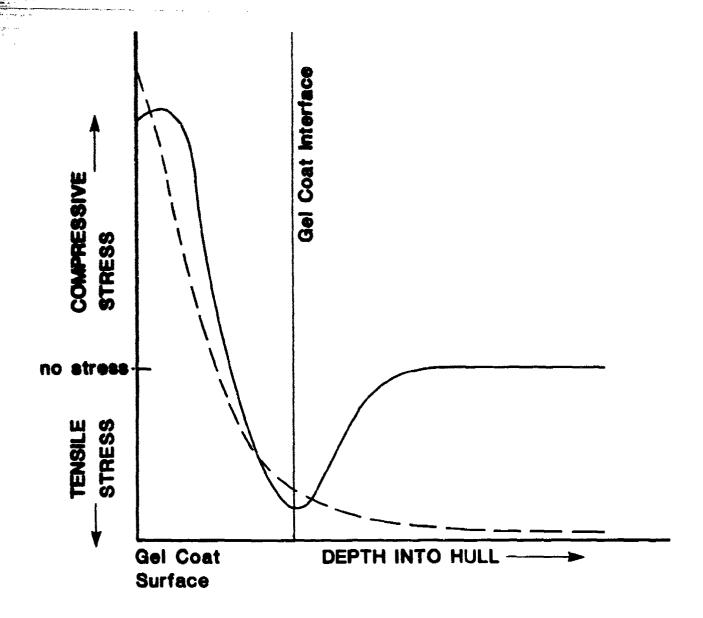
Figure 1 shows the relationship between water concentration and stress development. Note that the maximum tensile stress will develope under the surface and ahead of the diffusing water. If the tensile strength of the polymer is exceeded at the maximum tensile stress position, disk cracking will take place. Figure 2 shows such disk cracks formed under the surface of clear resin.

Figure 1. Sketch of a laminate cross-section.

The amount of water absorbed by the polymer is plotted with the dashed line. The absorbed water generates swelling stresses which are indicated by the solid line.

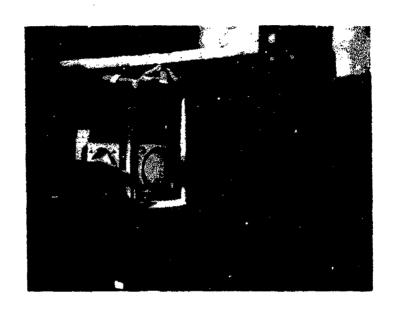
Samples were tested for blister resistance by immersion in a 65°C (149°C) constant temperature water bath. Figure 4 shows the acrylic sample holders which were designed during this project and used for one sided exposure. Samples were examined on a routine basis for blistering. The longest exposure time was 24 months. Blister initiation time, the time at which blisters are first observed, and blister severity (number and size of blister per cm²) were measured. Representative samples were cross-sectioned for polarized light microscopic examination and measurement of gel coat thickness. Two sets of each laminate were fabricated and tested.

Figure 4. Acrylic test tank designed for single-sided exposure of the laminates with the 65°C distilled water.

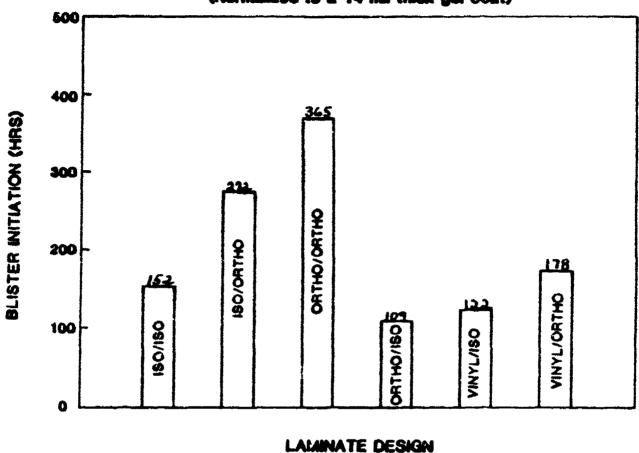
Figure 5 presents the results for blister initiation time on various samples. Other factors aside, the initiation time is a function of gel coat thickness as discussed in the section on water permeation. Comparisons of different laminates for blister initiation are meaningless unless gel coat thickness is either constant or the initiation time is corrected for thickness variations. A dry 30 mil gel coat will not show blistering for at least twice the time that a 15 mil gel coated laminate begins to blister.

Figure 5 shows that blister initiation time is also a function of both the laminating resin and the gel coat formulation. In rating the laminating resins for initiation time, orthophthalic resin was best in all cases. For the gel coat, the rating depended on the laminating resin. The NPG-orthophthalic gel coat was better than NPG-isophthalic which was better than vinyl when used with PG-orthophthalic laminating resins. When these same gel coats are used with isophthalic laminating resins the order becomes NPG-isophthalic was best, vinyl was intermediate and NPG-orthophthalic blistered most quickly. It appears from the birefringence, which is an optical effect caused by stress and is observed using a polarized microscope, that residual stresses created during lay-up and stresses produced by water diffusion related swelling account for some of these differences.

Figure 5. Blister initiation versus resin combination at 65°C (149°CF)

All gel coated thicknesses have been normalized to 14 mils.

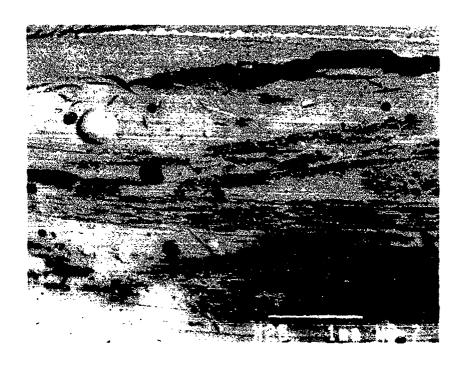
Figure 7. Scanning electron micrograph of a blister under a gel coat showing the interaction of the growing blister with stress cracks. The white phase is glass fiber. The circules are air bubbles. Gray phase is resin. Black regions are the blister and the stress cracks. Gel coat is seen above the blister.

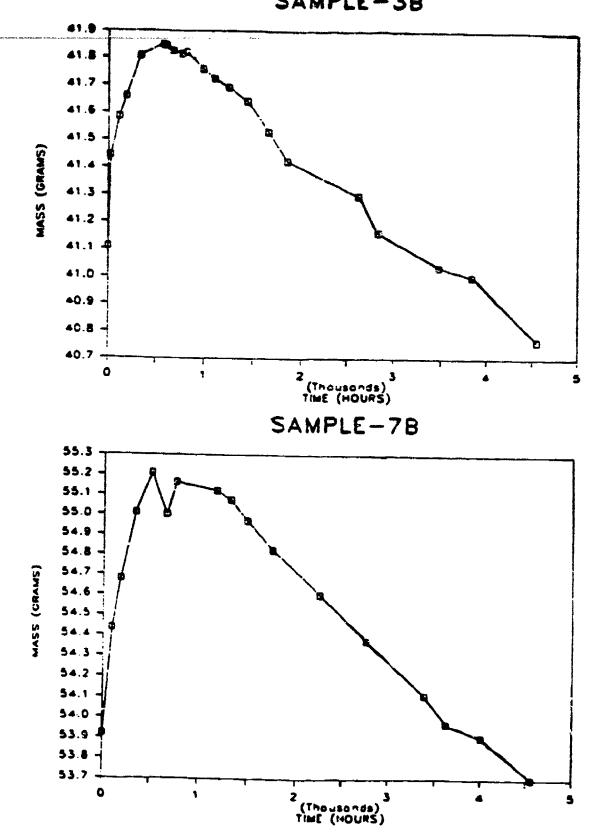
WSM units are held onto the polymer chains by weak forces. These forces can be eliminated by water molecules. When water diffuses into the hull, it dislodges WSM from the polymer chains, surrounds it with water and aids in the outward movement of the WSM. Figure 8 shows the weight change of two composite samples made in this study. The initial weight gain of the samples is due to water molecules moving into the polyester network. At 600 hours of immersion time, the sample begins to lose weight. This weight loss is caused by leaching and extraction of WSM from the resin. After a very long time,

Figure 8. Observed net weight changes for typical polyester composites. Samples were exposed to 65<sup>0</sup>C distilled water on all surfaces.

more than 4000 hours, parts of the network and some of the glass can also be attacked and leached out of the hull. The point at which weight loss overcomes water pick-up corresponds to about one year of continuous immersion in warm waters  $(760^{\rm F})$  and about three years of continuous immersion in cold water at a temperature of  $550^{\rm F}$ .
